## INFOMAR Survey Report: CV18\_03 Area: Celtic Sea

For:  
Marine Institute & Geological Survey Ireland

*RV Celtic Voyager*

July & August 2018

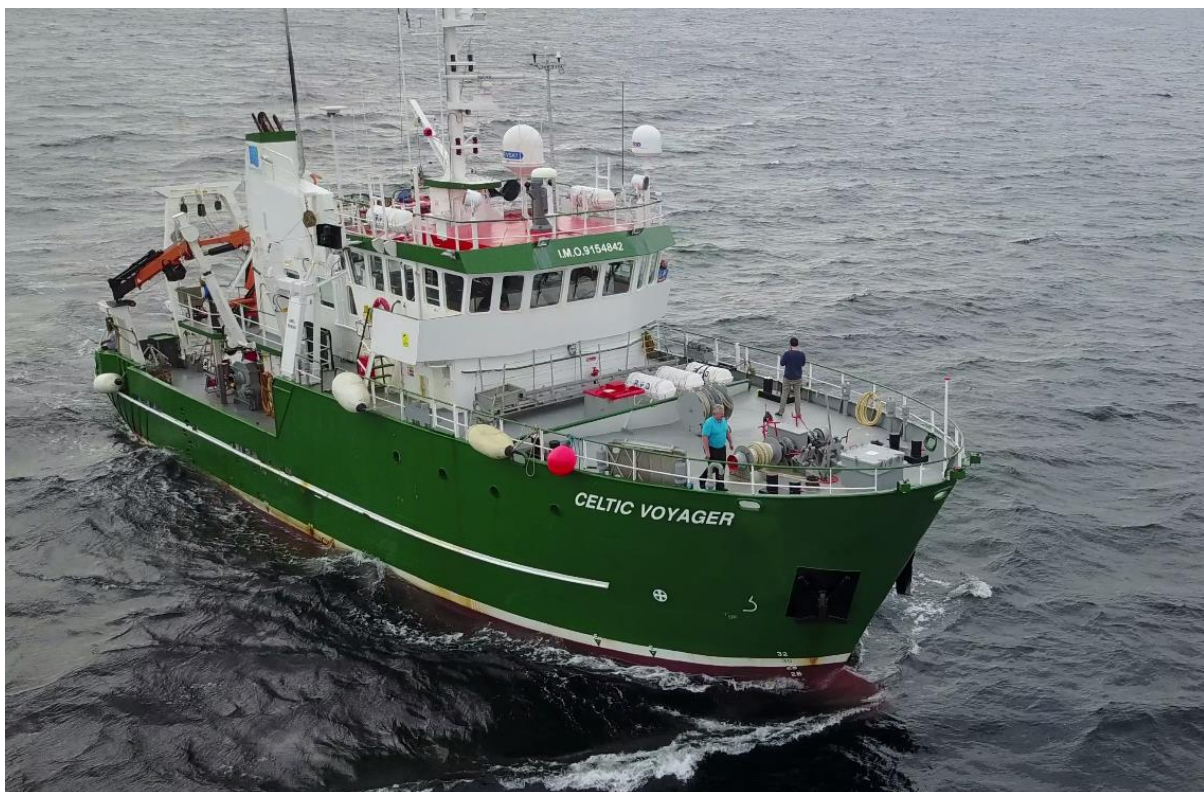
Figure 5: The RV *Celtic Voyager*.

The RV *Celtic Voyager* (figure 5) is a multipurpose research vessel owned by MI and managed by P&O Maritime. The vessel has wet, dry and chemical laboratories, which are permanently fitted with standard scientific equipment and can accommodate 8 scientists with a maximum endurance of 14 days. It has two hull mounted high resolution MBES systems, a Singlebeam Echo sounder (SBES), pinger source SBP and C-NAV Differential Global Navigation Satellite Systems (DGNSS) as primary navigation and a Seatex Seapath 330+ as secondary navigation and Motion Reference Unit (MRU).

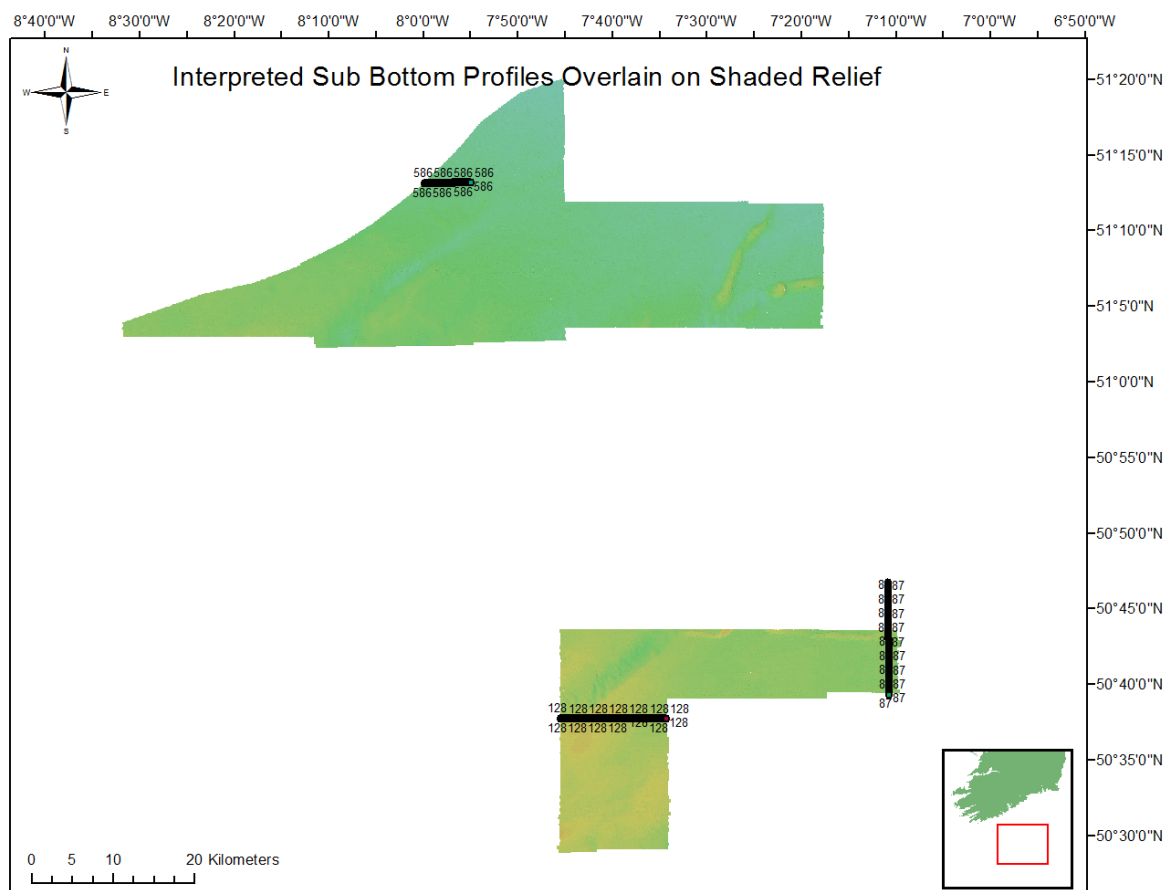
Figure 20: Sub bottom profile lines 087, 128 & 586 overlain on shaded relief data.

Tiff images and coda format seismic files were recorded for all SBP lines. Profile lines 087, 128 and 568 are selected for discussion here. Their geographical locations are shown in figure 20 where the profile extents have been overlain on shaded relief data. Profile 087 was acquired on a southerly heading in the southern data block. Profiles 128 and 586 were acquired on easterly headings in the southern and northern data blocks respectively.
