## INFOMAR Survey Report: CV19\_01 Area: Celtic Sea

For:  
Marine Institute & Geological Survey Ireland

*RV Celtic Voyager*

April 2019

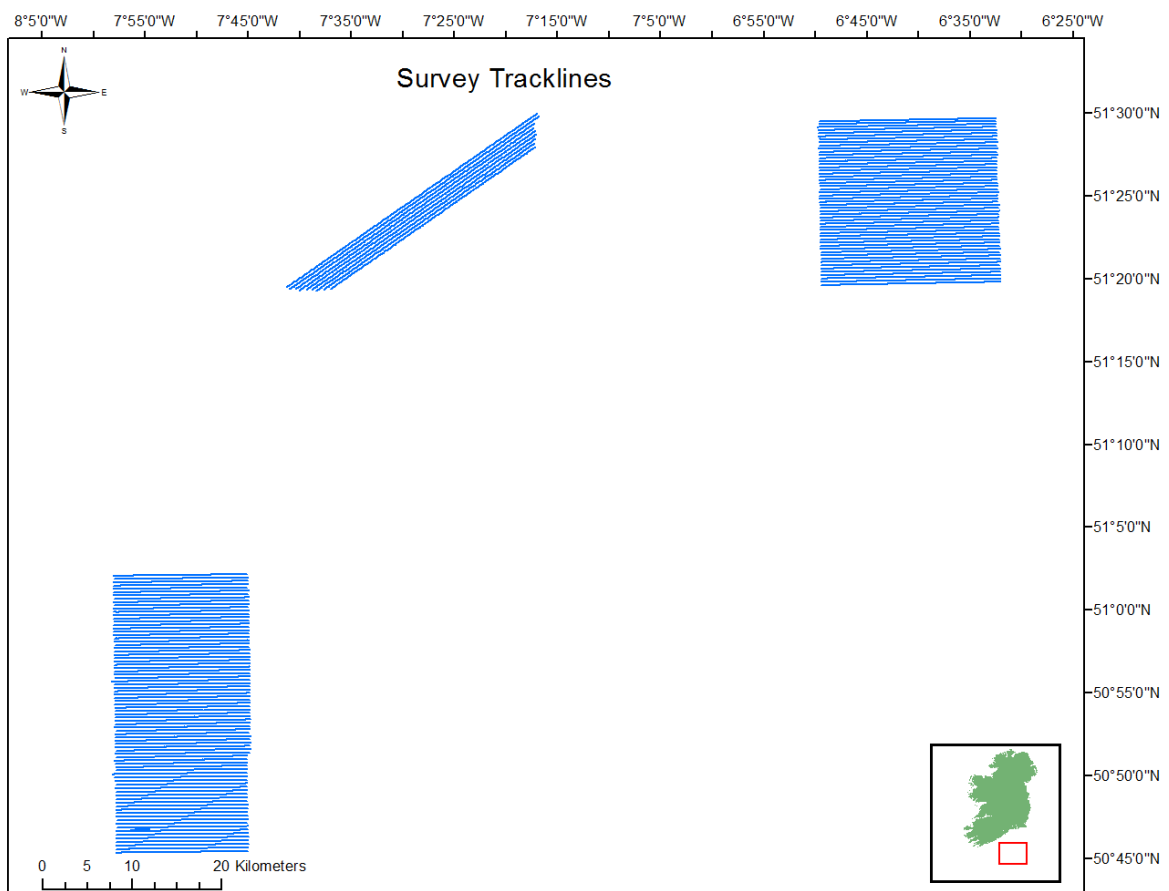
Figure 3: Survey trackline plot produced in Caris and ArcGIS software.

The final survey trackline plot is contained in figure 3. Mainlines were acquired on east – west and northeast – southwest reciprocal headings. Three separate survey polygons were mapped, denoted in this report as the west and east areas respectively.

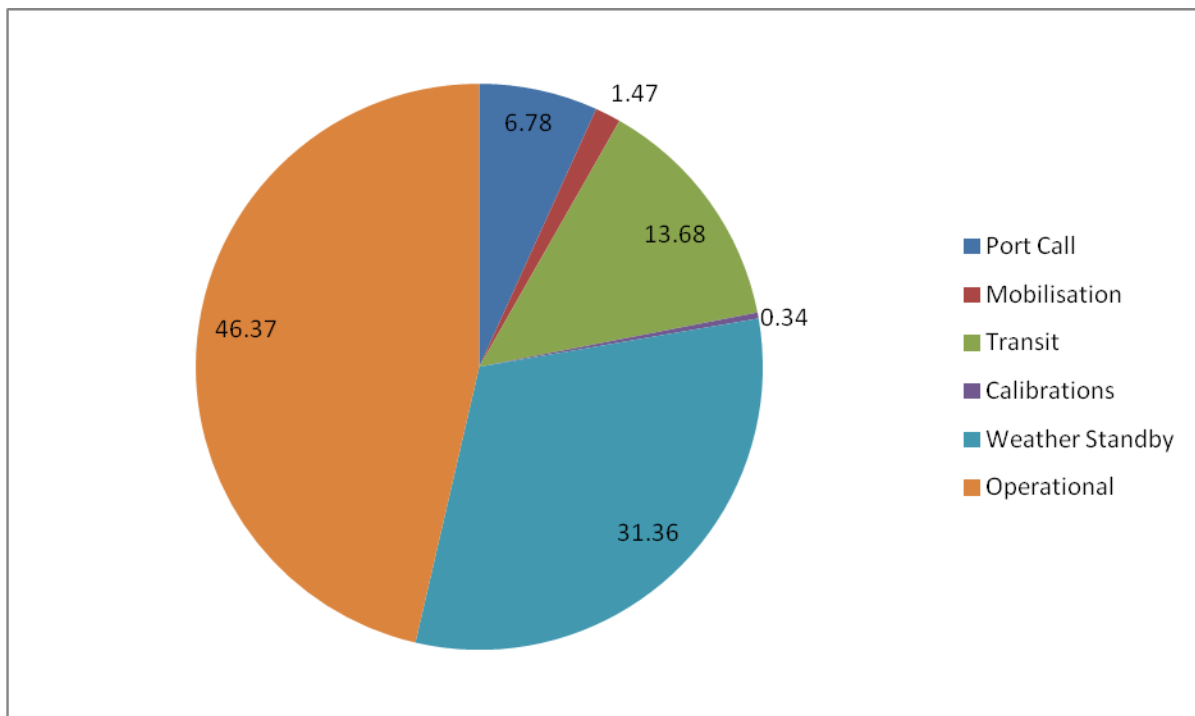
Figure 4: Survey statistics pie chart.

The pie chart in figure 4 presents the cumulative statistics from the final DPR. Survey data acquisition accounts for approximately 46% of the time.

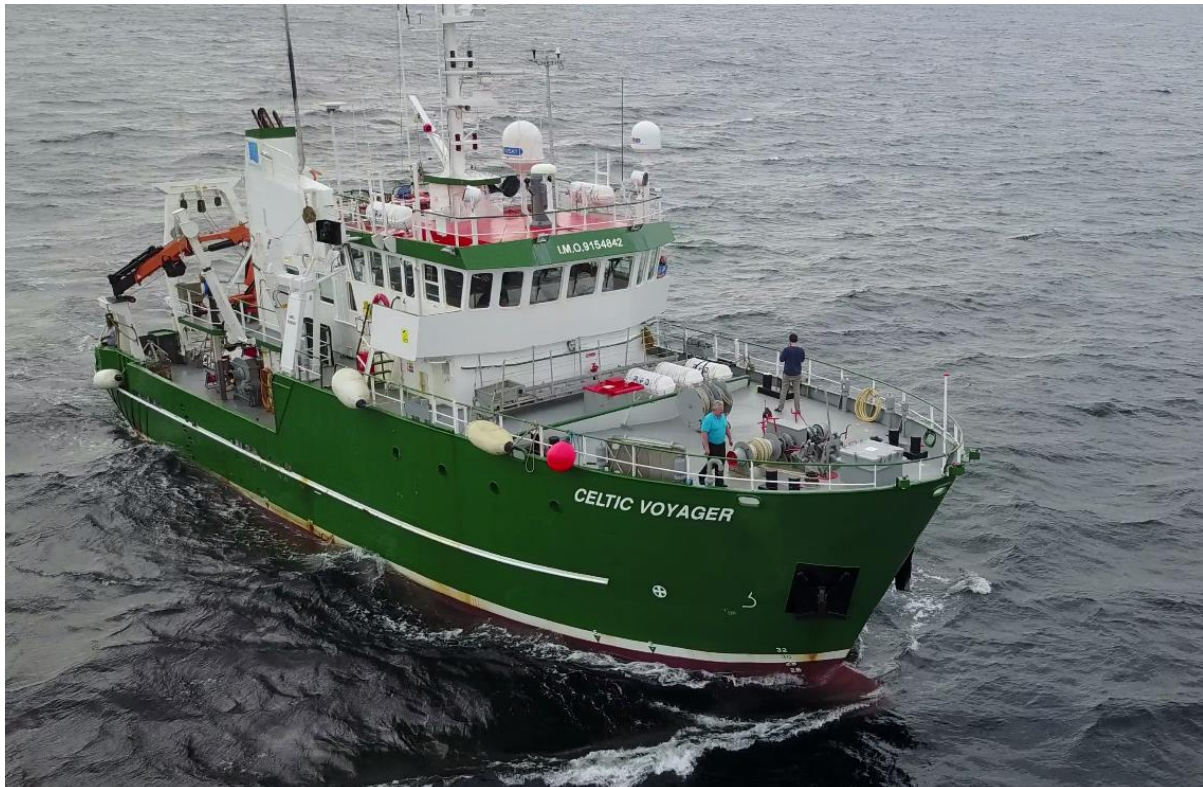
Figure 5: The RV *Celtic Voyager*.

The RV *Celtic Voyager* (figure 5) is a multipurpose research vessel owned by MI and managed by P&O Maritime. The vessel has wet, dry and chemical laboratories, which are permanently fitted with standard scientific equipment and can accommodate 8 scientists with a maximum endurance of 14 days. It has a hull mounted high resolution EM2040 MBES system, a Singlebeam Echo sounder (SBES), pinger source SBP and C-NAV Differential Global Navigation Satellite Systems (DGNSS) as primary navigation and a Seatex Seapath 330+ as secondary navigation and Motion Reference Unit (MRU). All necessary geophysical and DGPS positioning equipment were pre-installed, calibrated and tested prior to commencement of survey activities.

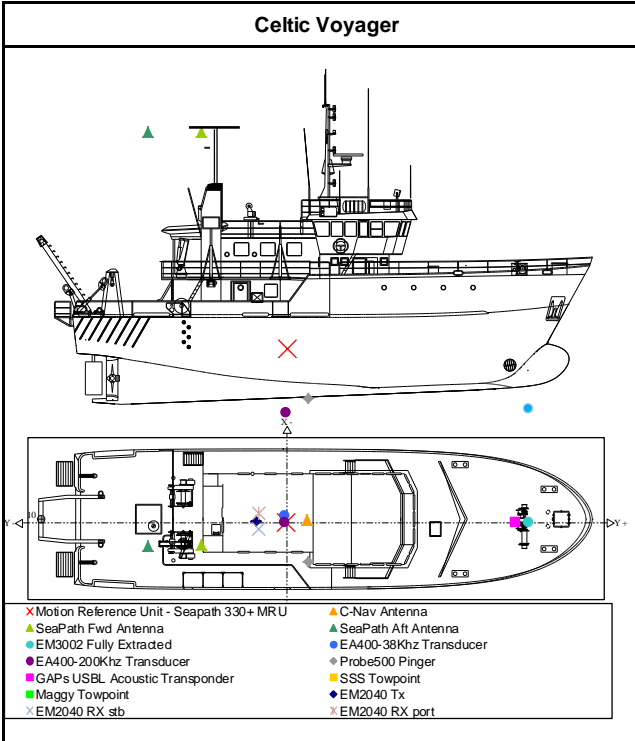
Table 5: Vessel offsets and installation angles.

<ul style="list-style-type: none"> <li>✗ Motion Reference Unit - Seapath 330+ MRU</li> <li>▲ SeaPath Fwd Antenna</li> <li>● EM3002 Fully Extracted</li> <li>● EA400-200Khz Transducer</li> <li>● GAP's USBL Acoustic Transponder</li> <li>● Maggy Towpoint</li> <li>✗ EM2040 RX stb</li> <li>▲ C-Nav Antenna</li> <li>▲ SeaPath Aft Antenna</li> <li>● EA400-38Khz Transducer</li> <li>◆ Probe500 Pinger</li> <li>● SSS Towpoint</li> <li>◆ EM2040 Tx</li> <li>✗ EM2040 RX port</li> </ul>					
No'	Offset Name	X	Y	Z	Reason for change
	Common Reference Point (CRP)	0.000	0.000	0.000	
1	Motion Reference Unit - Seapath 330+ MRU	0.000	0.000	0.000	
2	C-Nav Antenna	-0.114	0.965	14.396	
3	SeaPath Fwd Antenna	0.924	-3.993	13.292

4	SeaPath Aft Antenna	0.984	-6.491	13.299	
5	EM3002 Fully Extracted	-0.078	11.190	-3.532	New Position 2015
6	EA400-38Khz Transducer	-0.343	-0.122	-3.783	
7	EA400-200Khz Transducer	-0.036	-0.115	-3.783	
8	Probe500 Pinger	1.636	0.989	-3.004	
9	GAP's USBL Acoustic Transponder	-0.077	10.633	-4.332	
10	SSS Towpoint	0.000	-13.905	1.987	
11	Maggy Towpoint	-3.835	-13.905	1.987	
12	EM2040 Tx	-0.064	-1.417	-4.863	New Position
13	EM2040 RX stb	0.279	-1.287	-4.693	New Position
14	EM2040 RX port	-0.411	-1.288	-4.696	New Position
Surveyor: Fabio Sacchetti		Checked: Kevin Sheehan		Date: 11/01/2016

EM2040 geometry	10-11/01/2016		
	X (forward)	Y (starboard)	Z(+Down)
Pos Com1( C-Nav)	0.965	-0.114	-14.396
EM2040 TX	-1.417	-0.064	4.863
EM2040 RX Port head	-1.288	-0.411	4.696
EM2040 RX Starboard head	-1.287	0.279	4.693
Seapath aft	-6.491	0.984	-13.299
Seapath fore	-3.993	0.924	-13.292
MRU 5+	0.000	0.000	0.000

Bluepix Report 10&11/01/2016 Killybegs			
Item	Yaw	Roll	Pitch
MRU 5+	0.57	0.07	0.21
EM2040 TX	-0.05	-0.37	0.74
EM2040 RX Port	-0.83	39.68	0.67
EM2040 RX Stb	0.69	-40.28	0.73
Seapath	-1.39	N/A	N/A
EM3002	0.68	-0.47	-0.14

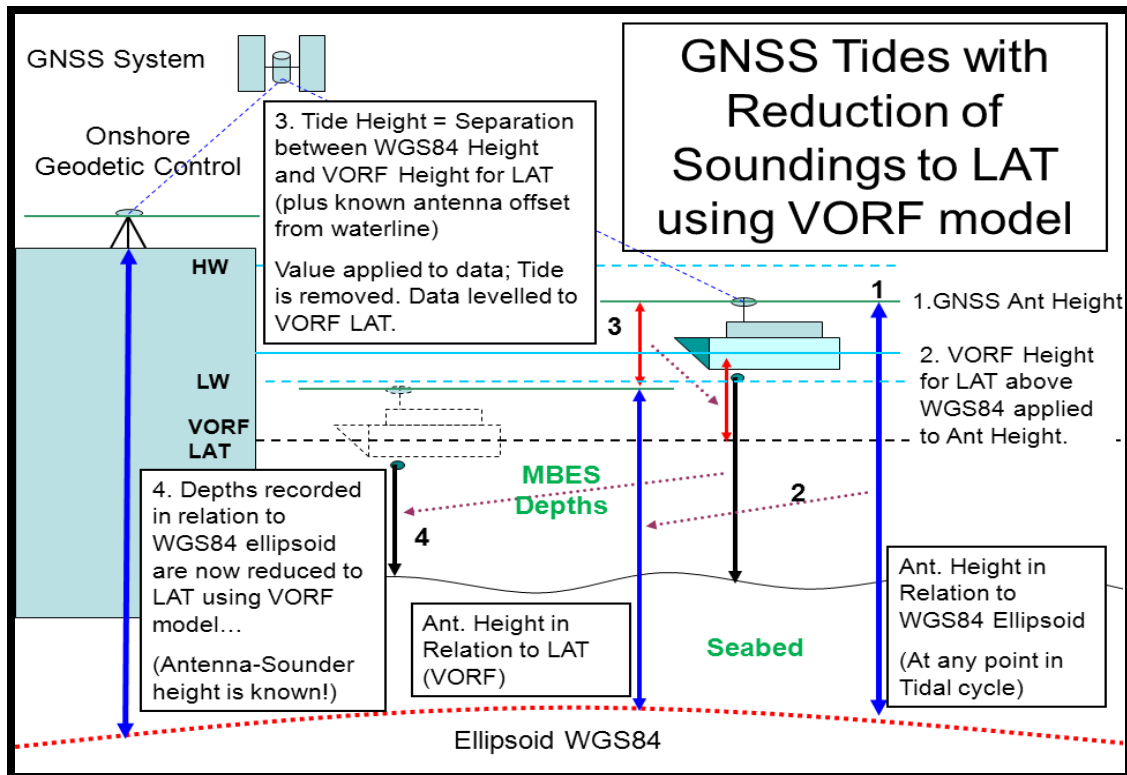
Figure 6: GNSS tides to LAT using VORF model.

Table 7 above details the vertical and horizontal datum applied during operations. Global Navigation Satellite Systems (GNSS) tides do not require us to account for vessel draft or vessel squat values, as recorded depths are related directly to the World Geodetic System (WGS) 84 Ellipsoid. These values were reduced to Lowest Astronomical Tide (LAT) using GNSS tidal measurements and by then applying the Vertical Offshore Reference Frame (VORF) model (LAT/WGS84 separation) as illustrated in figure 6 below.

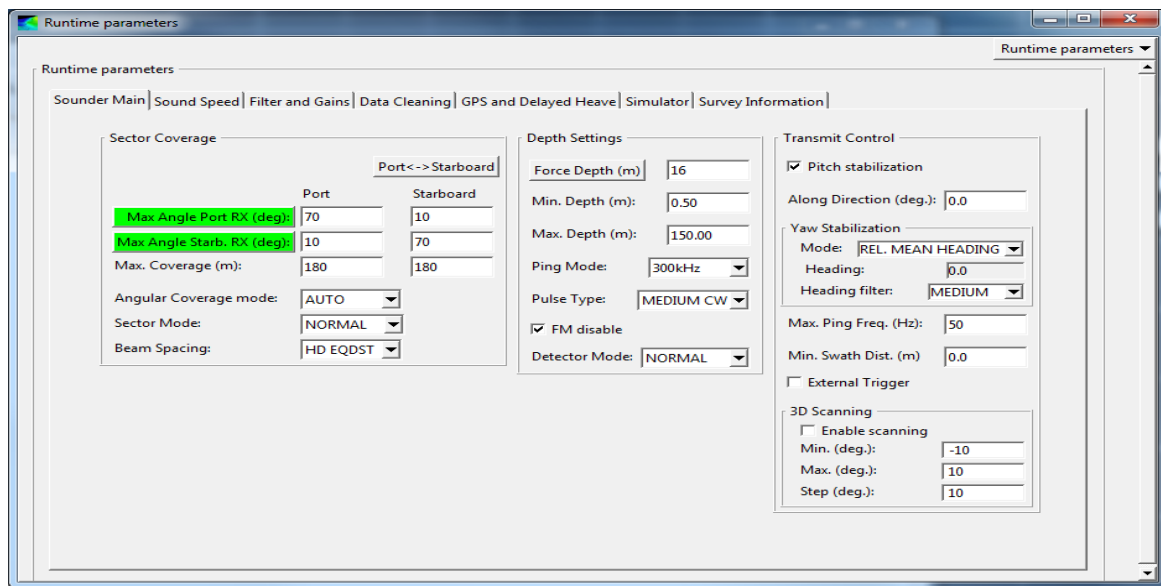
Figure 7: Runtime parameters window in SIS.

Most of the important acquisition parameters are set in the Runtime Parameters module of SIS. Figure 7 shows an example of settings in the Sounder Main tab in Runtime Parameters. Max angle and max coverage parameters were adjusted to take account of depth, sea state, sound velocity conditions and seafloor character. Pulse type for survey mainlines and crosslines was maintained at FM and ping mode set to 200 kHz, which maximised swath width in the depths encountered. Wreck surveys were performed at Medium CW or Long CW and at 300 kHz to provide maximum resolution.

Max angle, sector mode, vessel speed and pulse type were adjusted to attain maximum resolution for wreck inspections. Water Column data were acquired for all survey lines and stored directly to external disk.

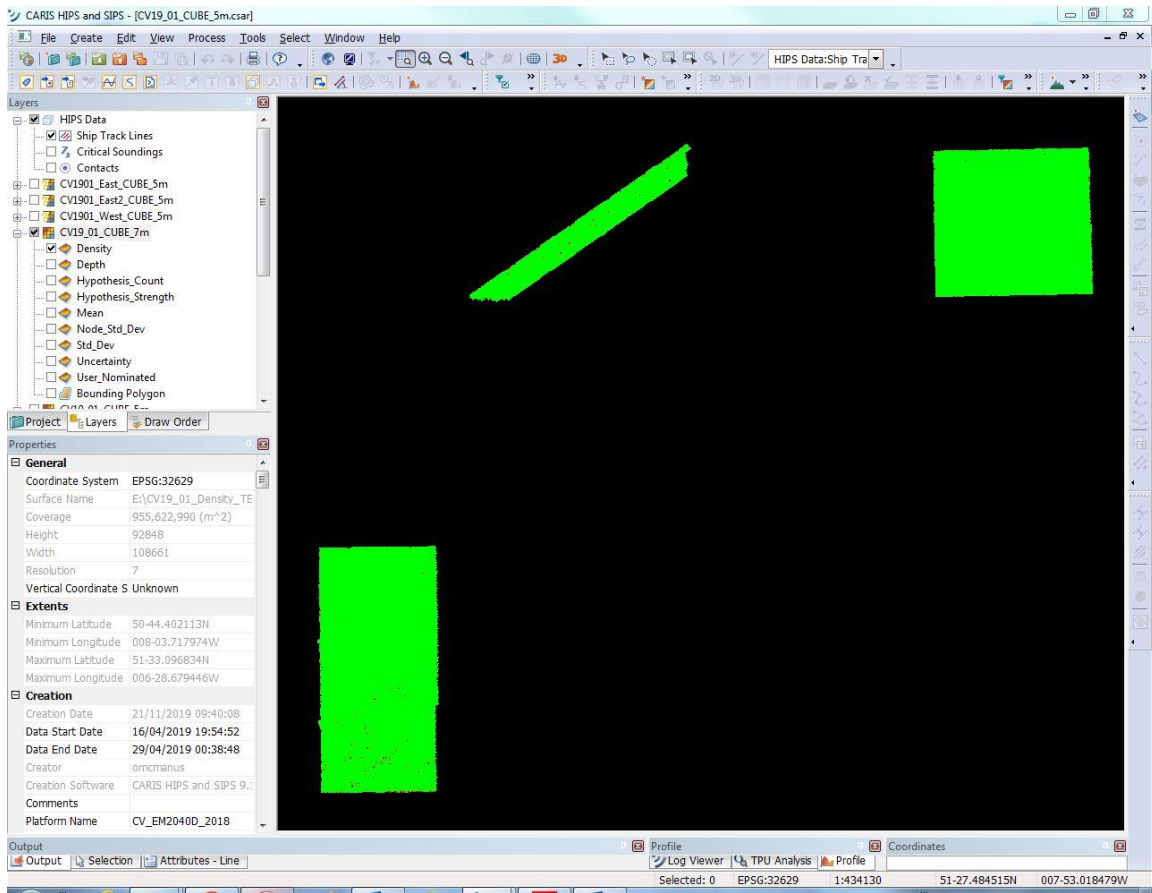
Figure 8: Sounding density traffic light plot.

The minimum standard for feature detection for an Order 1a survey are cubic features > 2 m in depths up to 40 m and 10% of depth beyond 40 m. Feature detection is not relevant for water depths greater than 100 m where a general description of the seafloor is deemed adequate for Order 2 survey specification. Water depths range from 71 to 111 m. The minimum sized cubic features that require detection are 7.1 m, i.e. 10% of water depth. A minimum of 9 soundings per 7.1 m bins are required in order to attain the feature detection criteria. A bin size of 7 m was selected to QC the data density and the results are shown in figure 8.

The mean number of soundings per bin was computed at 76. This easily exceeded the 9 soundings required per bin. Green indicates where 9 soundings per bin were achieved and red where the 9 soundings requirement was not attained.

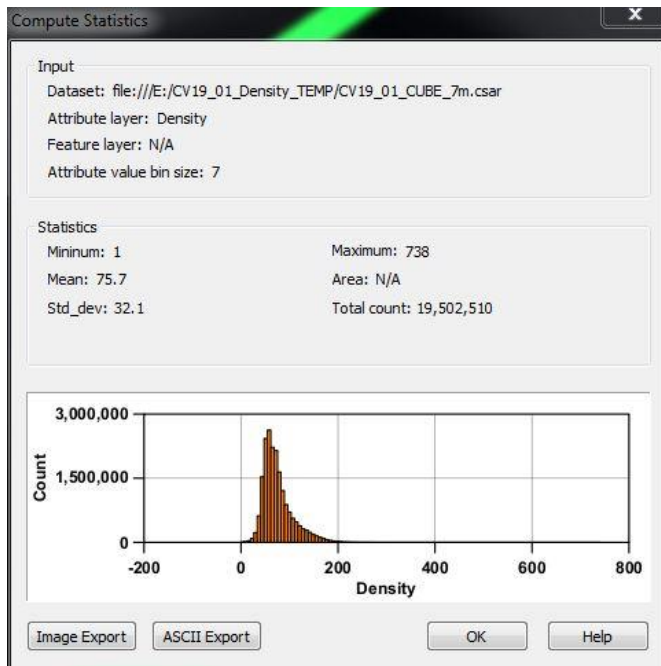
Figure 9: Sounding density statistics, north area.

Figure 9 shows the statistics associated with the data density QC.

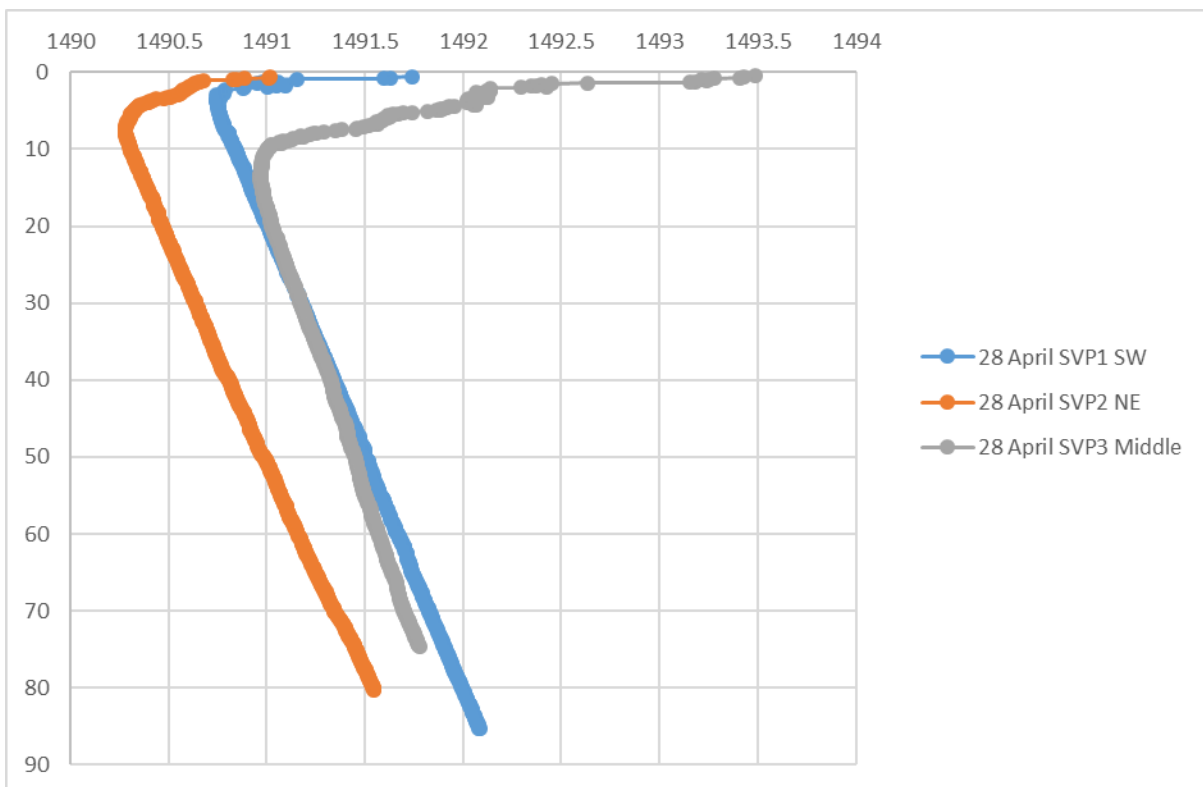
Figure 10: SVP comparison plot 28<sup>th</sup> August

A profile comparison plot from 28<sup>th</sup> April is shown in figure 10. Three profiles were acquired at different locations along a survey lines to show the variation in conditions. Sound velocity in metres per second is plotted on the x axis and depth in metres on the y axis.

Profiles show a large difference between near surface sound velocities. The water column is well mixed from 3 m depth in the case of the SW profile, from 12 m depth in the Middle profile and from 8 m depth in the NE profile. Velocity increases with pressure beneath these respective depths. The near surface shows a distinct layering as seen by the rapid variation in sound speed with depth.

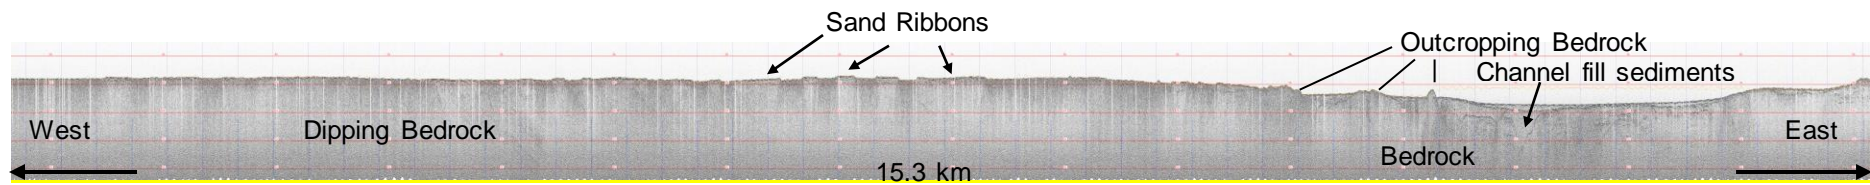
Figure 21: Sub bottom profile interpreted image, line 0165.

Interpreted sub bottom profiler tiff images of survey lines 059, 165 and 268 are shown in figures 20, 21 and 22 respectively. A bandpass filter with low cut 2.2 kHz and high cut 4.7 kHz was applied in processing, along with a suitable gain. Heave compensation is applied to the images displayed. Horizontal scale lines are at 10 metre intervals for all sub bottom images below.

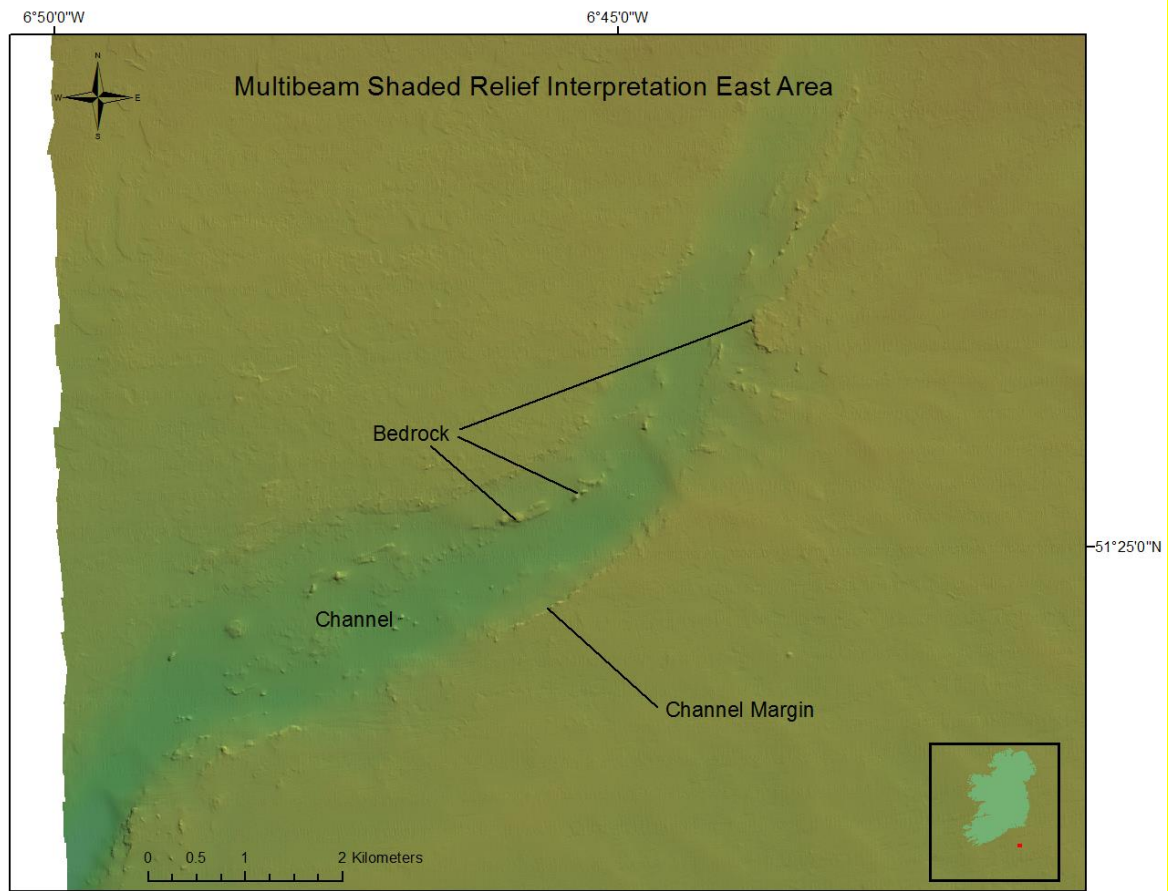
Figure 30: Multibeam shaded relief illustrating channel in east area.

Figure 30 is a shaded relief illustrating the channel situated in the east area. It is sinuous in character and up to 3 km in width. Outcropping bedrock is evident on both margins and within the channel itself. The channel widens and deepens to the southwest. It is the extension of a feature mapped in previous years.

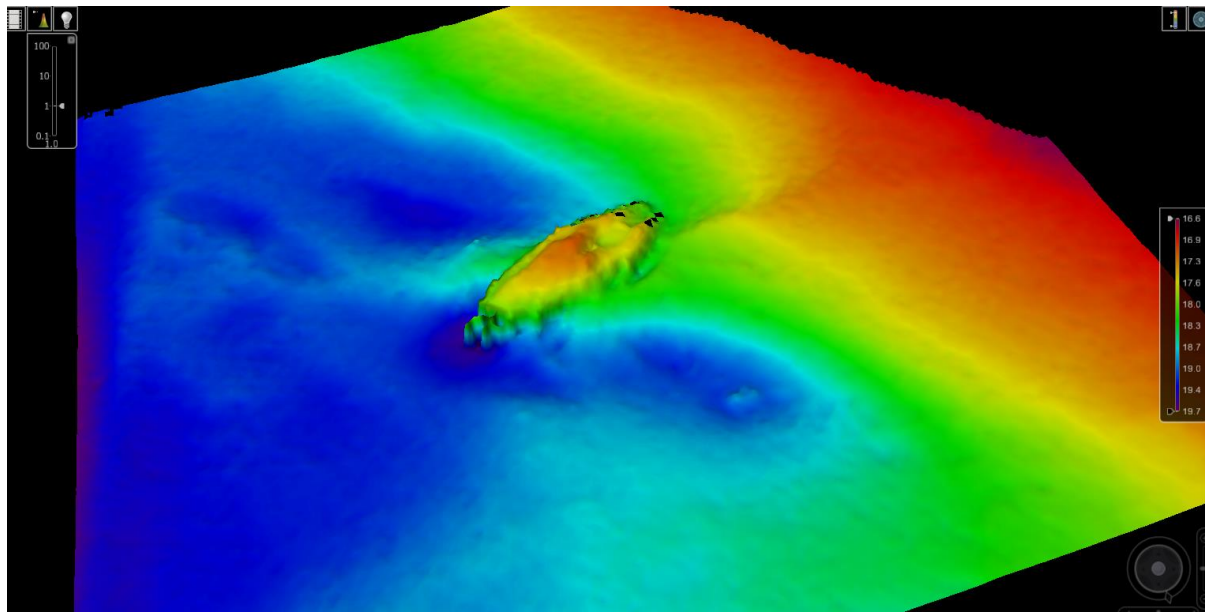
Figure 32: Mapped wreck, number 1.

A total of four wrecks were identified from multibeam data. A detailed wreck survey was completed on one of these wrecks. This wreck was discovered during the course of a patch test in Cork Harbour. It is situated at the edge of the navigable channel, north of Roches Point. The Harbour Master was informed and a hydrographic wreck report (H525) was issued to the UKHO. Figure 32 shows the wreck.

Table 16 provides the wreck metadata for this wreck. Adverse weather hampered our ability to map the other wrecks in detail and this work will be done in subsequent surveys during 2019.
